1901 DRYDEN ROAD SOUTH DAYTON DUMP AND LANDFILL SITE Moraine, Ohio

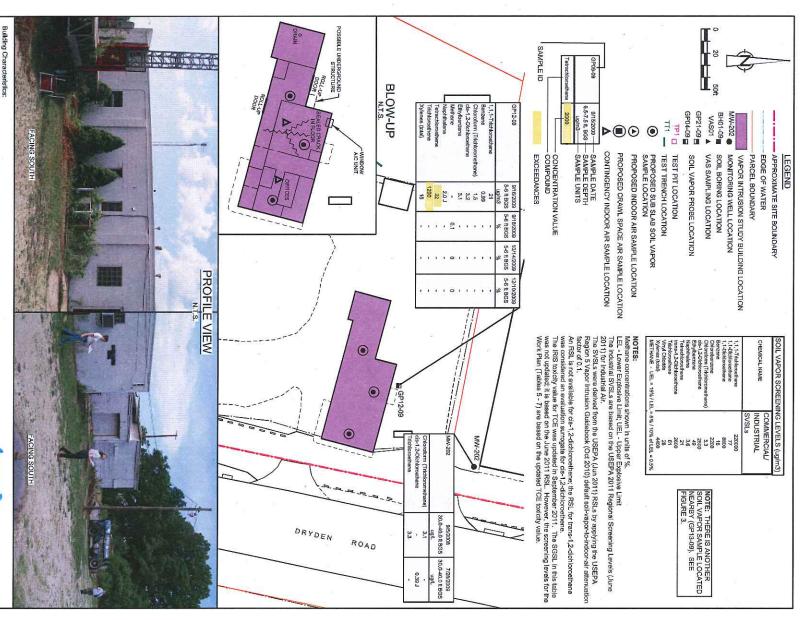
inv, commercial-use building, constructed prior to 1949. 4,557 sq. ft. slab-on-grade, unsealed concrete building, inv, commercial-use building, represent a southwest comer of warehouse. Large or cracks observed in middle portion of building. Floor staining observed in warehouse and rear storage shed. UST removed from former Conway Fence facility in 1990. Weather seals in poor condition. Overhead doors me of building survey. Heated by forced air natural gas furnace. Central A/C present in retail and office areas, in the A/C present in northern portion of building. Exterior openings - vents, fans, utility pipe penetrations,
